# THERMONUCLEAR EFFECTS ON REACTIVE ARRAY RADOME MATERIALS

Rockwell International Corporation  
5701 West Imperial Highway  
Los Angeles, California 90009

1 December 1977

Final Report for Period 1 April 1977–31 November 1977

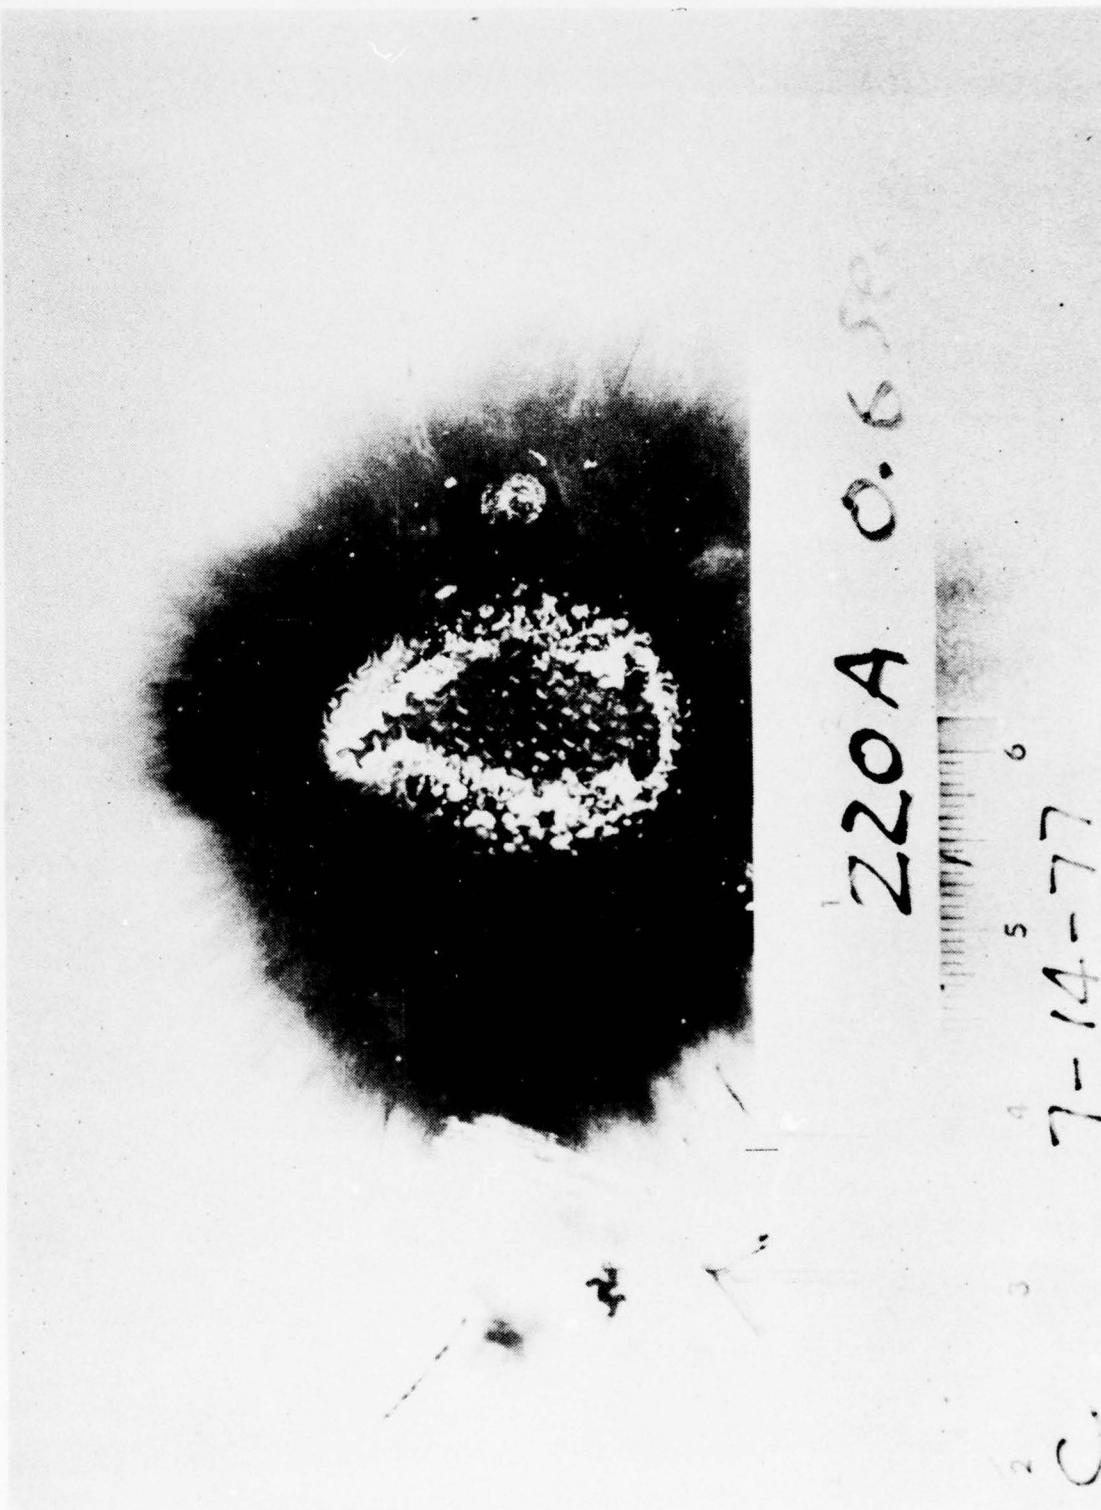
Figure 28. Long-duration discharge to 14-mil array.

Test XXV. Utilized the panel tested in series XVIII. This 0.014-inch-thick, copper-clad panel would sustain a strike for 0.6 second before termination caused by metal removal. During this period, there was severe metal damage in an area 3/4-inch wide and 1-1/4-inch long. This damage area is illustrated in Figure 28.

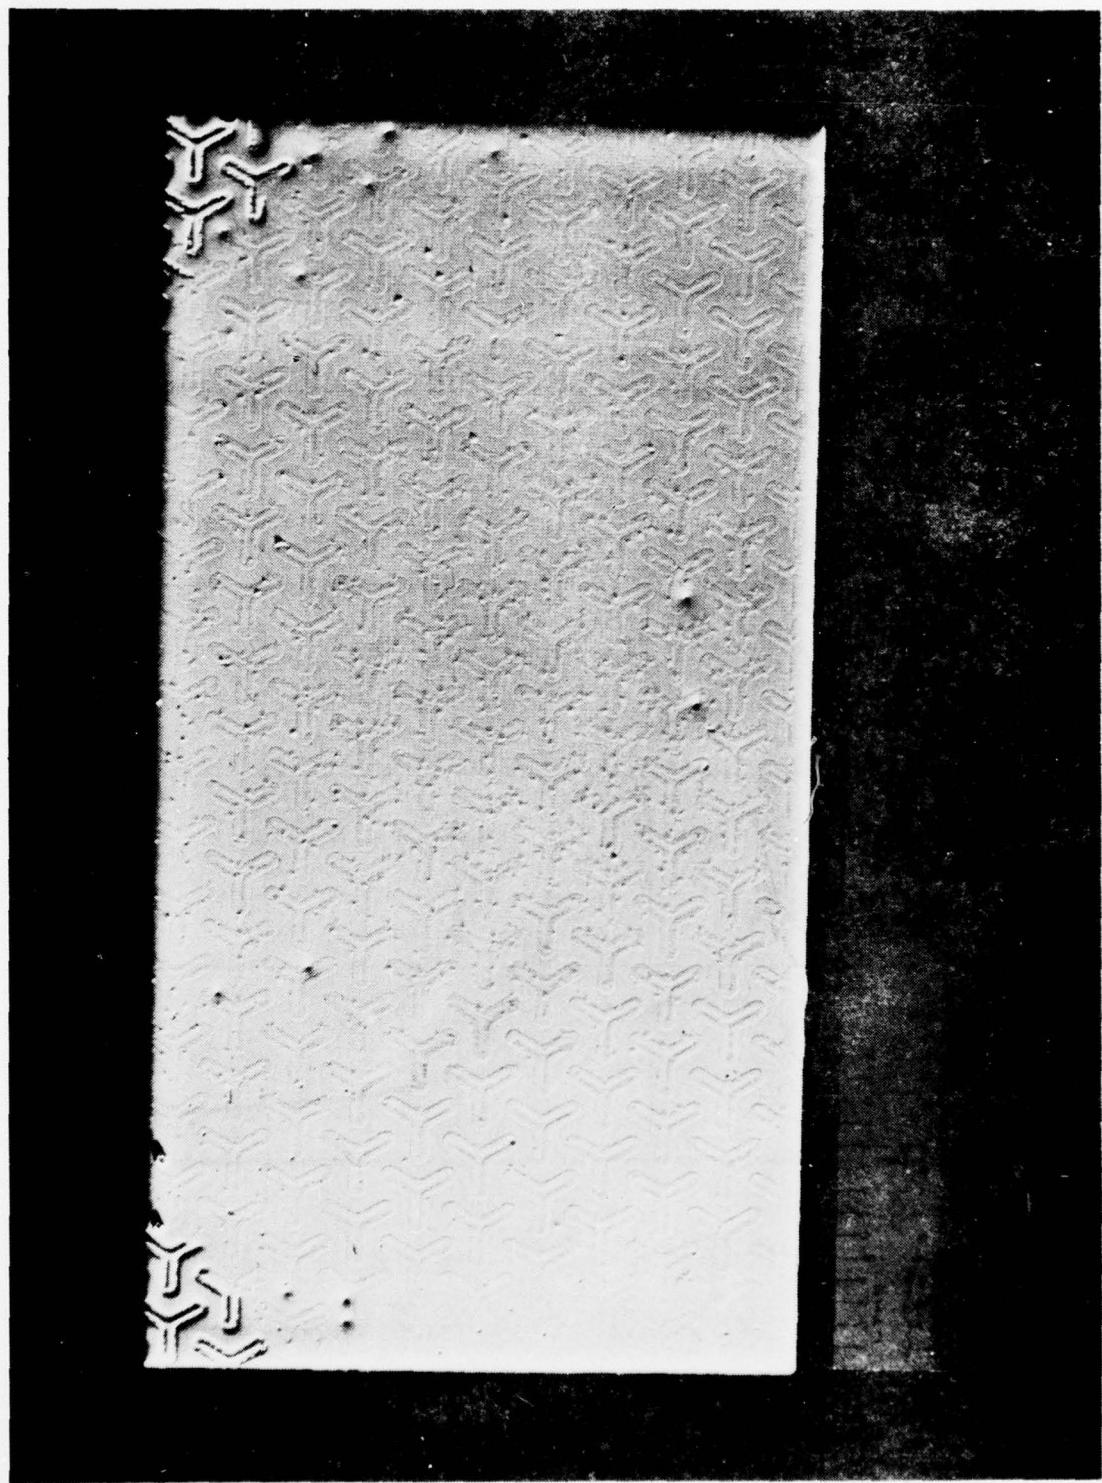
Figure 33. 14-mil array after thermonuclear exposure.

The thermal nuclear pulse shape used is illustrated in nondimensional form in Figure 32. The reactive array radome specimens were exposed to flux levels greater than 55 calories per centimeter square. The specimens finished with white polyurethane rain erosion coating suffered severe coating degradation after 1 pulse. The low thermal resistance of the polyurethane polymer ( $300^{\circ}$  F) allowed the coating to melt and flow. The specimens coated with the high-temperature resistant ( $500^{\circ}$  F) fluoroelastomer rain erosion coating survived 10 thermal nuclear pulses, with only minor coating degradation in the form of minor pinholes. No charring was evident. The specimens coated with MIL-C-83286 white aliphatic polyurethane paint survived the 10 thermal nuclear pulses, with only minor coating degradation similar to that observed with the white fluoroelastomer erosion coating. The minor pinholing is shown in Figures 33 and 34. Figure 33 illustrates that the thicker 0.014-inch copper with its higher specific heat capacity pinholed less than the 0.004-inch copper shown in Figure 34. Neither array thickness allowed discoloration or electrical degradation of the panels.
